**Project Description:** CCTV Survey

**Project Date:** 25/03/2022

**Inspection Standard:** MSCC5 Sewers & Drainage GB (SRM5 Scoring)

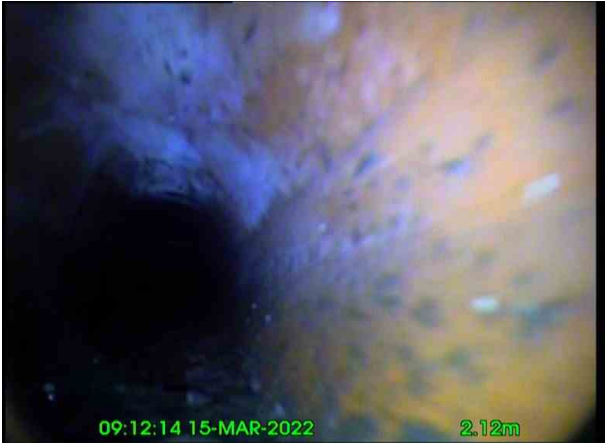
Item No.	Inspection Direction	PLR	Client's Job Ref	Contractor's Job
2	Downstream	MH1X

Section	PLR	Grade	Description
2	MH1X	3	Settled deposits, fine, 5% cross-sectional area loss, finish
5	MH2X	4	Settled deposits, fine, 20% cross-sectional area loss, finish
19	UpstreamX	3	Multiple defects
20	FW1X	3	Multiple defects
21	Upstream AX	4	Settled deposits, hard or compacted, 20% cross-sectional area loss
33	Upstream CX	3	Multiple defects
41	G4X	3	Joint displaced, medium

MH1X\_b43df53d-609a-458e-a9be-14dbc89b0d00\_20220325\_094845\_311.jpg, 00:00:15, 2.12 m  
Settled deposits, fine, 5% cross-sectional area loss, start

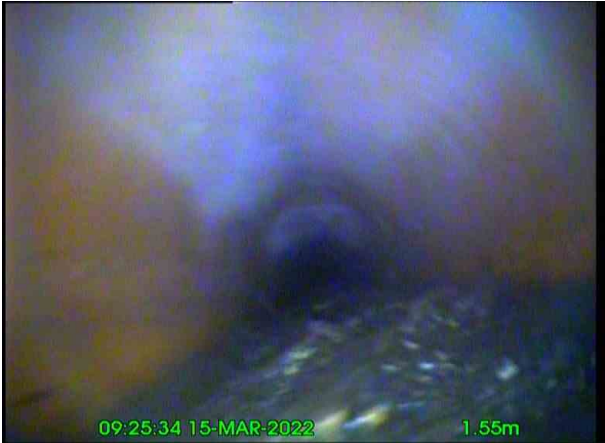
Item No.	Inspection Direction	PLR	Client's Job Ref	Contractor's Job Ref
5	Downstream	MH2X

MH2X\_6ed0165d-9cb4-4e35-bfa0-d64781de6bf2\_20220325\_095911\_500.jpg, 00:00:18, 1.55 m  
Settled deposits, fine, 20% cross-sectional area loss, start

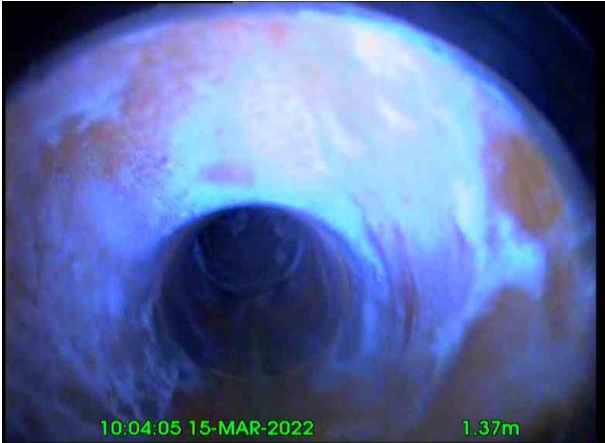
Item No.	Inspection Direction	PLR	Client's Job Ref	Contractor's Job Ref
15	Downstream	G3X

G3X\_4cd04e6e-d3a8-4bd8-bd38-c7489fa40021\_20220325\_1  
05732\_222.jpg, 00:00:18, 1.37 m  
Open joint, medium

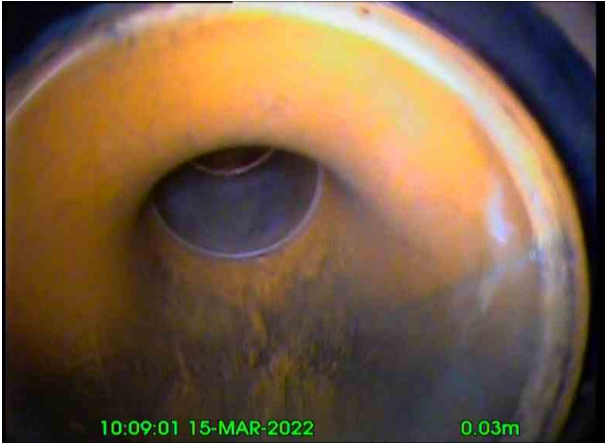
Item No.	Inspection Direction	PLR	Client's Job Ref	Contractor's Job Ref
16	Upstream	UPSTREAM AX

Upstream  
AX\_05fba197-0138-4ba2-8a5e-4def130e685b\_20220325\_110  
008\_194.jpg, 00:00:06, 0.03 m  
Open joint, medium

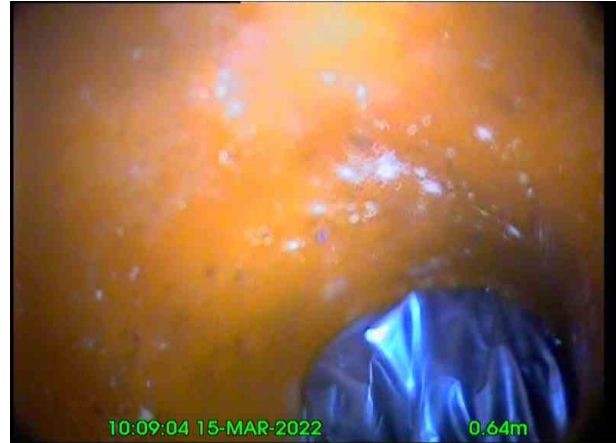
Upstream  
AX\_c552cb72-7d20-44f1-855d-86cfbdabbe33\_20220325\_110  
119\_226.jpg, 00:00:09, 0.67 m  
General remark, Line not in use

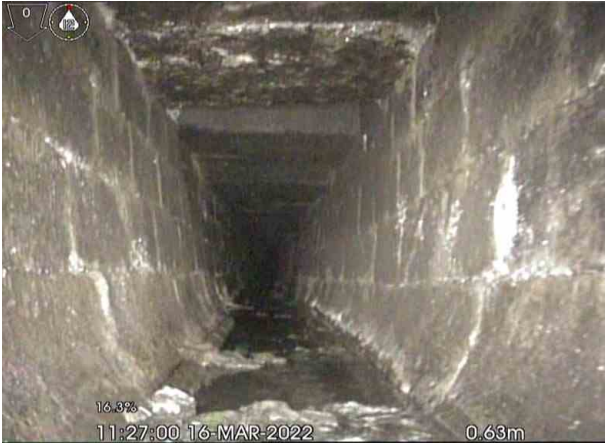
Item No. 20	Inspection Direction Downstream	PLR FW1X	Client's Job Ref	Contractor's Job Ref
----------------	------------------------------------	-------------	------------------	----------------------

FW1X\_a870c394-b1ae-4fb1-9286-213b03305d5b\_20220325\_113153\_900.jpg, 00:00:13, 0.63 m  
Settled deposits, fine, 10% cross-sectional area loss, start

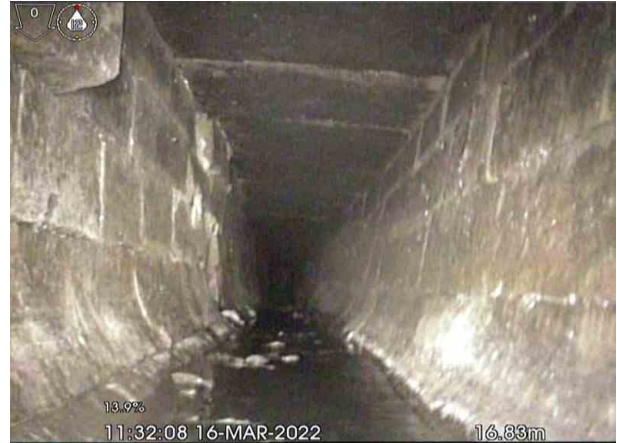
FW1X\_e6eae0cb-a708-4923-b384-21f7473d81db\_20220325\_113926\_689.jpg, 00:05:20, 16.83 m  
Settled deposits, fine, 10% cross-sectional area loss

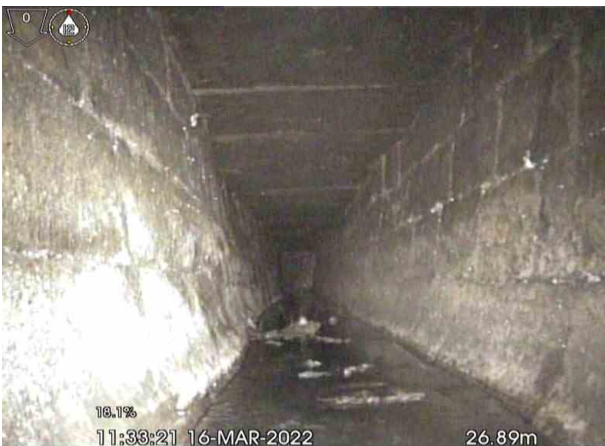
FW1X\_69f4a7af-3fb3-41be-b891-e3a4ea12a504\_20220325\_114750\_905.jpg, 00:06:33, 26.89 m  
Settled deposits, fine, 10% cross-sectional area loss, start

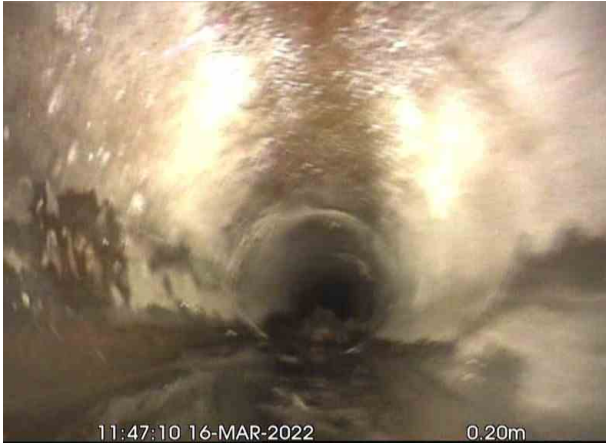
Item No.	Inspection Direction	PLR	Client's Job Ref	Contractor's Job Ref
21	Upstream	UPSTREAM AX

Upstream  
AX\_2c24e93e-4de1-43ce-b970-b5e972d89093\_20220325\_144410\_439.jpg, 00:00:06, 0.20 m  
Settled deposits, fine, 10% cross-sectional area loss, start

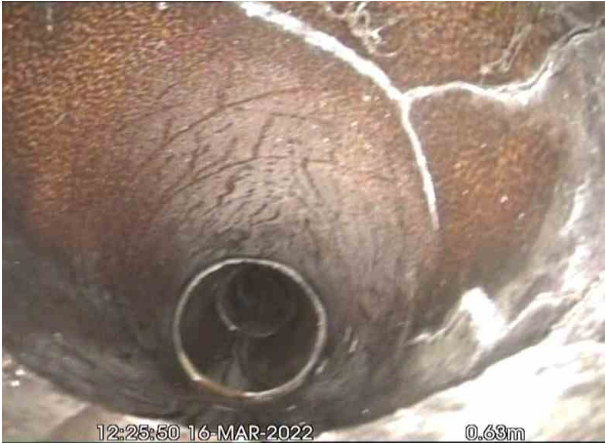
Item No.	Inspection Direction	PLR	Client's Job Ref	Contractor's Job Ref
24	Downstream	MH6X

Section	PLR	Grade	Description
24	MH6X	3	Fracture, circumferential from 10 o'clock to 2 o'clock
41	G4X	5	Collapsed drain or sewer

MH6X\_5309bed7-a537-438a-8c0b-1f0c109ae0b2\_20220325\_153220\_137.jpg, 00:00:05, 0.63 m  
Fracture, circumferential from 10 o'clock to 2 o'clock

Grade 3: Best practice suggests consideration should be given to repairs in the medium term.

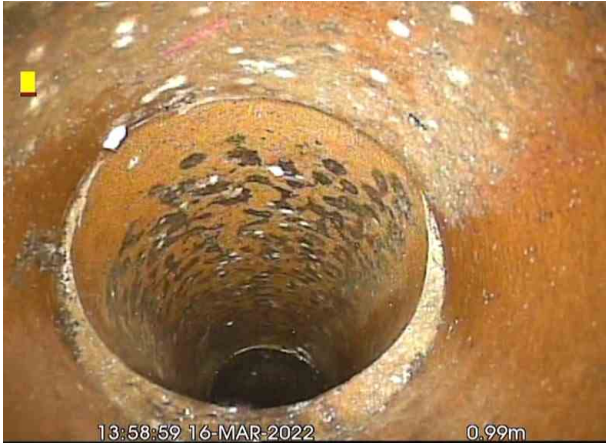
Item No. 33	Inspection Direction Upstream	PLR UPSTREAM CX	Client's Job Ref	Contractor's Job Ref
----------------	----------------------------------	--------------------	------------------	----------------------

Upstream  
CX\_d54a2afe-a992-4310-b46b-aa03cded51ee\_20220328\_09  
4322\_567.jpg, 00:00:09, 0.99 m  
Joint displaced, medium

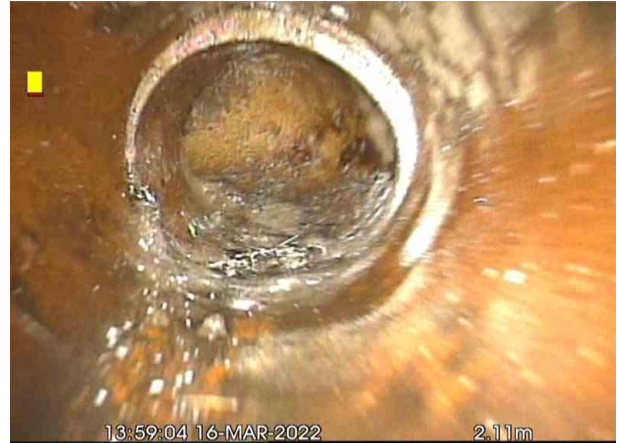
Upstream  
CX\_9d66b288-b33d-4a4e-9219-ed65493c2be2\_20220328\_09  
4356\_650.jpg, 00:00:14, 2.11 m  
Joint displaced, medium

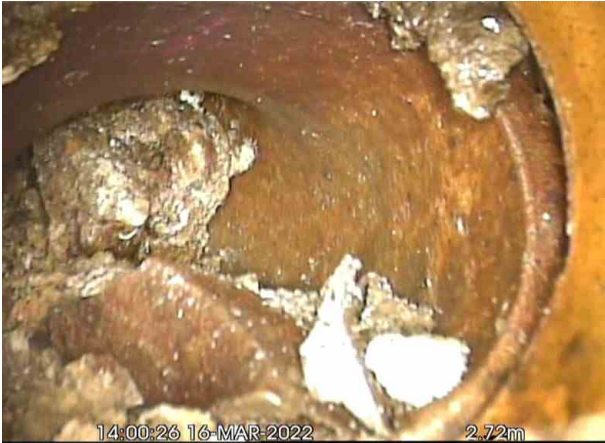
Item No.	Inspection Direction	PLR	Client's Job Ref	Contractor's Job Ref
34	Upstream	UPSTREAM DX

Upstream  
DX\_69da25b6-9ce7-4ede-9e5f-d45e484d3679\_20220328\_09  
4624\_431.jpg, 00:00:14, 2.72 m  
General remark, Not in use

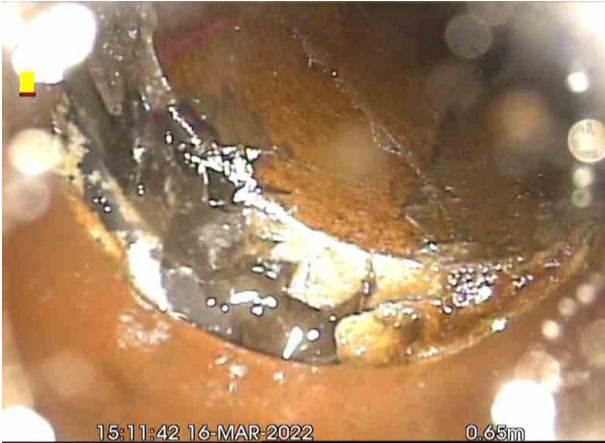
Item No. 41	Inspection Direction Downstream	PLR G4X	Client's Job Ref	Contractor's Job Ref
----------------	------------------------------------	------------	------------------	----------------------

15:11:42 16-MAR-2022 0.65m  
G4X\_796243bf-c306-4f28-8d52-dd3f4df6e185\_20220328\_111658\_902.jpg, 00:00:07, 0.65 m  
Joint displaced, medium

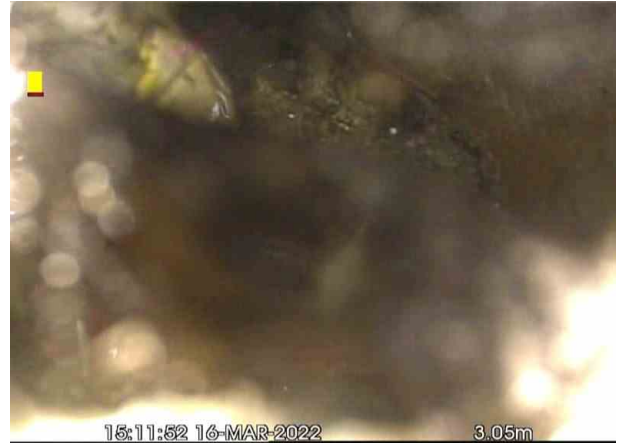
15:11:52 16-MAR-2022 3.05m  
G4X\_85d306e3-1930-4205-adca-cf8b8c4505d7\_20220328\_111723\_938.jpg, 00:00:17, 3.05 m  
Collapsed drain or sewer

Grade 5: Best practice suggests that this pipe is at risk of collapse at any time. Urgent consideration should be given to repairs to avoid total failure.
