**Project Description:** CCTV Survey

**Project Date:** 25/03/2022

**Inspection Standard:** MSCC5 Sewers & Drainage GB (SRM5 Scoring)

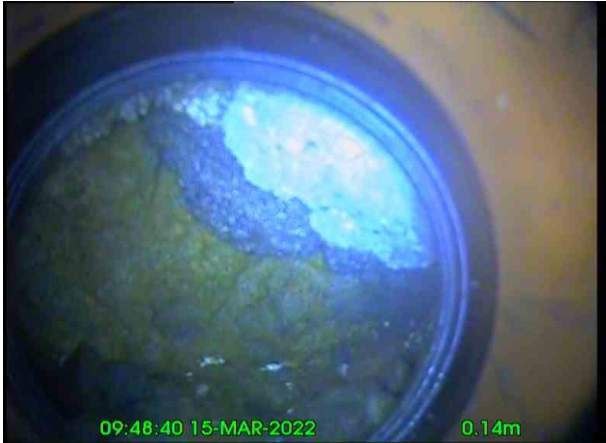
AX\_35bb7120-a2b5-439a-9655-40578e3a6294\_20220325\_10  
2724\_795.jpg, 00:00:09, 0.14 m  
General remark, Line not in use

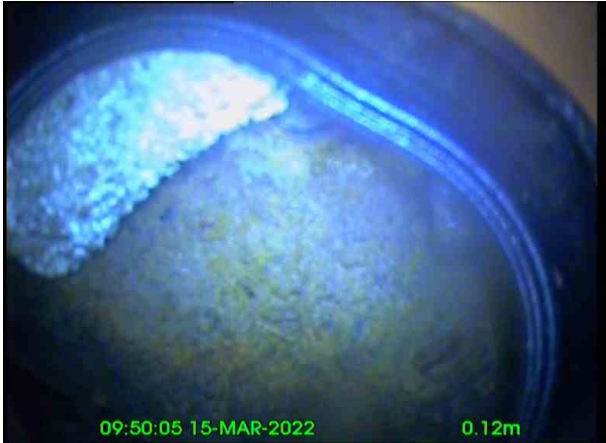
BX\_3f2c2cae-c6e8-473d-bcac-a95f9b3d4654\_20220325\_102  
921\_163.jpg, 00:00:11, 0.12 m  
General remark, Line not in use

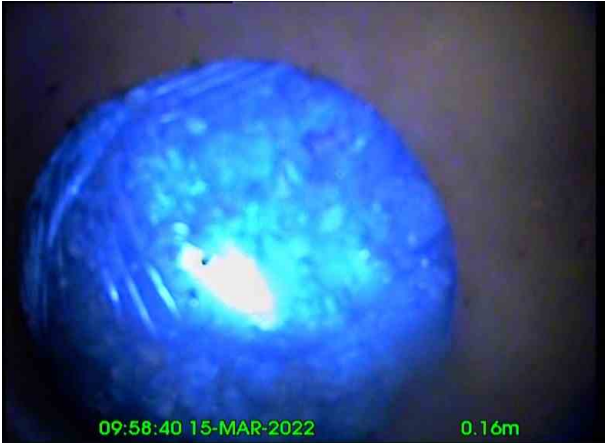
AX\_6d2ef415-36e3-403f-ab0a-113be594d2bb\_20220325\_105  
004\_908.jpg, 00:00:11, 0.15 m  
General remark, Line not in use

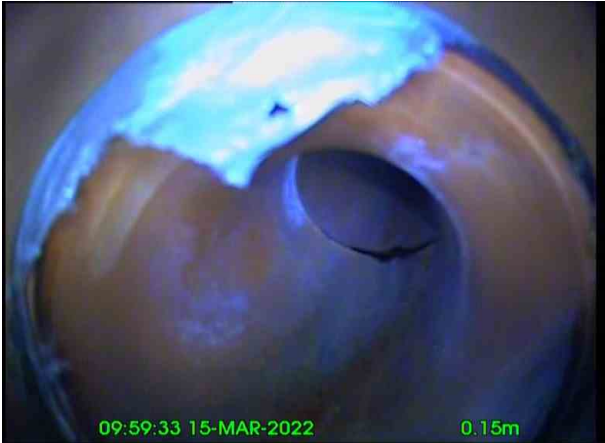
BX\_2e0b9347-0169-4ead-b68c-c013e015c66b\_20220325\_10  
5216\_084.jpg, 00:00:08, 0.15 m  
General remark, Plastic jammed in joint

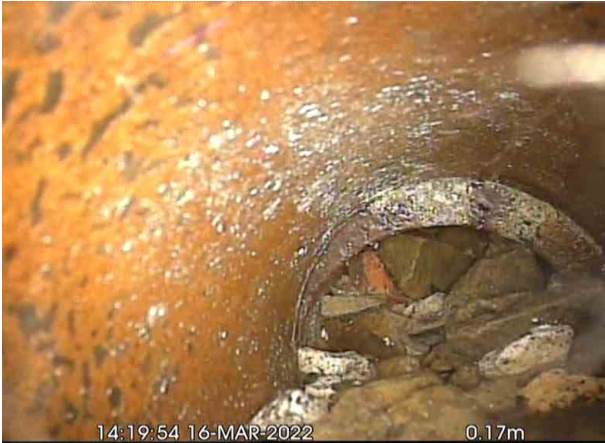
AX\_7c99f96d-474c-4a0e-8b27-04398331b5c6\_20220328\_110  
519\_702.jpg, 00:00:08, 0.17 m  
General remark, Line not in use
